## **Minerals Inspection Report**

Mine Name: RDS 502/West Desert Mine	Permit Number:	M/023/0067	Mine Status:	Inactive
Operator Name: West Desert Granite L.C.	Inspection Date:	04/02/2015	Permit Fees:	Delinquent
Inspector(s): Wayne H. Western	Inspection Time:	1:00 - 1:30 pm	Bond Amount:	\$33,250
Attendee(s): Joelle McCarthy	Weather:	Clear and fare	Bond Escalation:	05/08/2011
Inspection Purpose: Follow up from enforcement			Prior Inspection:	09/19/2014

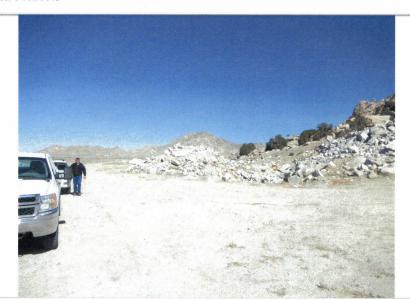
The mining that did occur was in the bedrock. There had beens some unauthorized blasting at the site which created several small stones that people could collect.

Lighter colored material was rocks blasted by illegal mining activities.

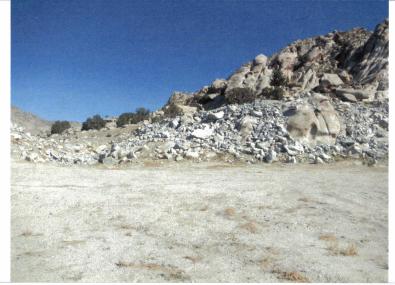
Flat area could be used for the community pit or recreating.

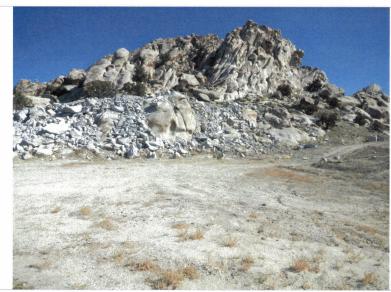
Road in the left of the photo might be reclaimed prior to turning the site into a community pit.

The only reclamation that could be needed was to reclaim some roads that had been create for mining. Those roads are shown in the photographs. The BLM might want to keep the roads open to help the public access the community pit. Once the BLM decides what direction to go the BLM and the Division will either seek bond forfeiture or return the bond to the Operator.

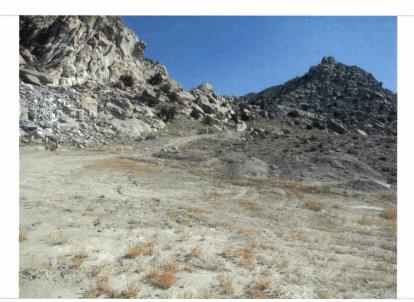
Mine road in center going north might be ripped and seeded if not compatible with the community pit.
